## Detailed UXO Risk Assessment

***Project:***

***Site Location:***

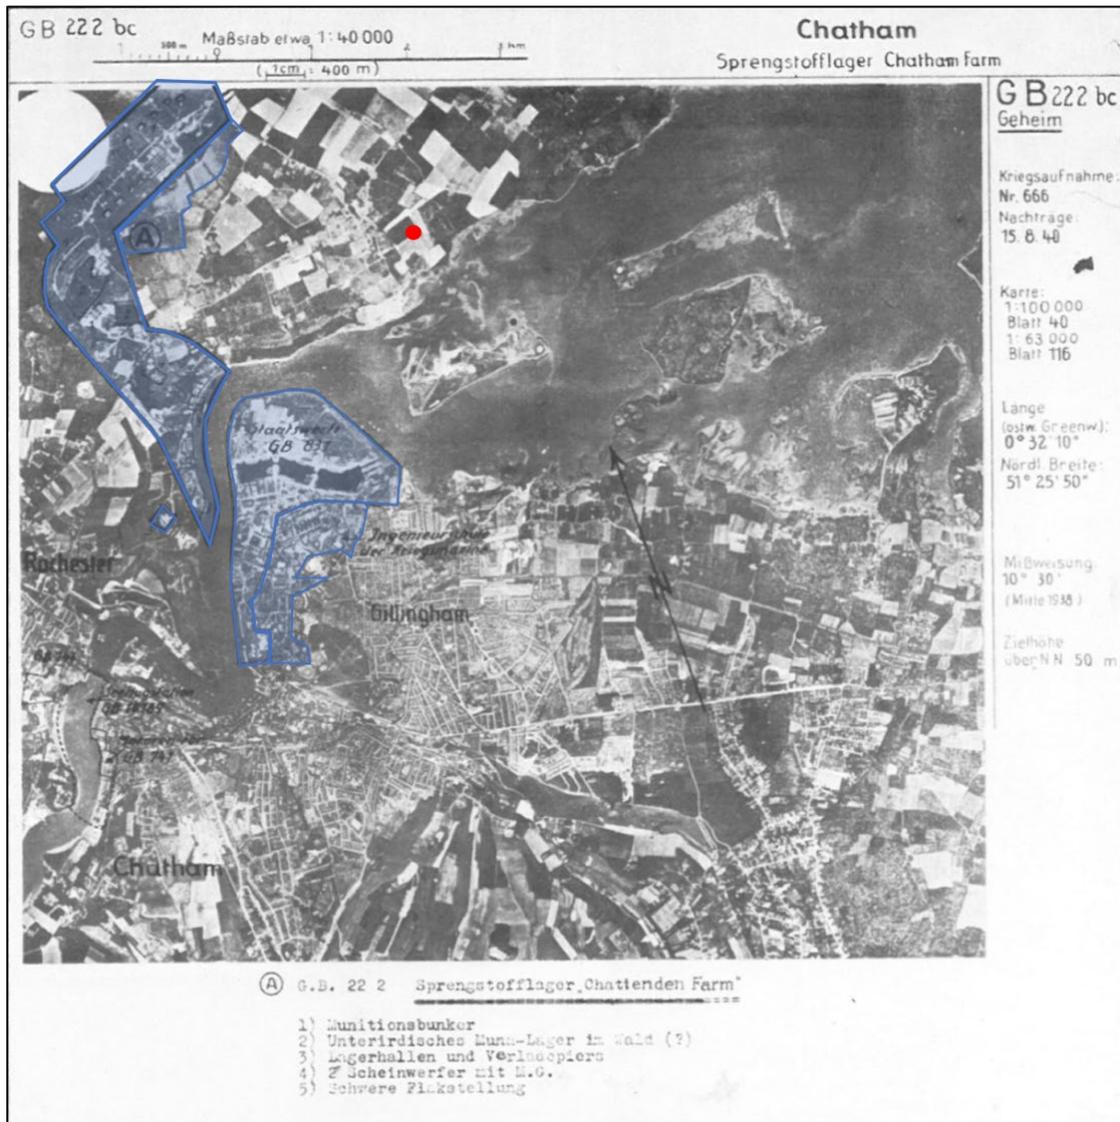
Figure 3. Showing Luftwaffe target areas in the area surrounding the site. The Luftwaffe targets are shown in red and blue.

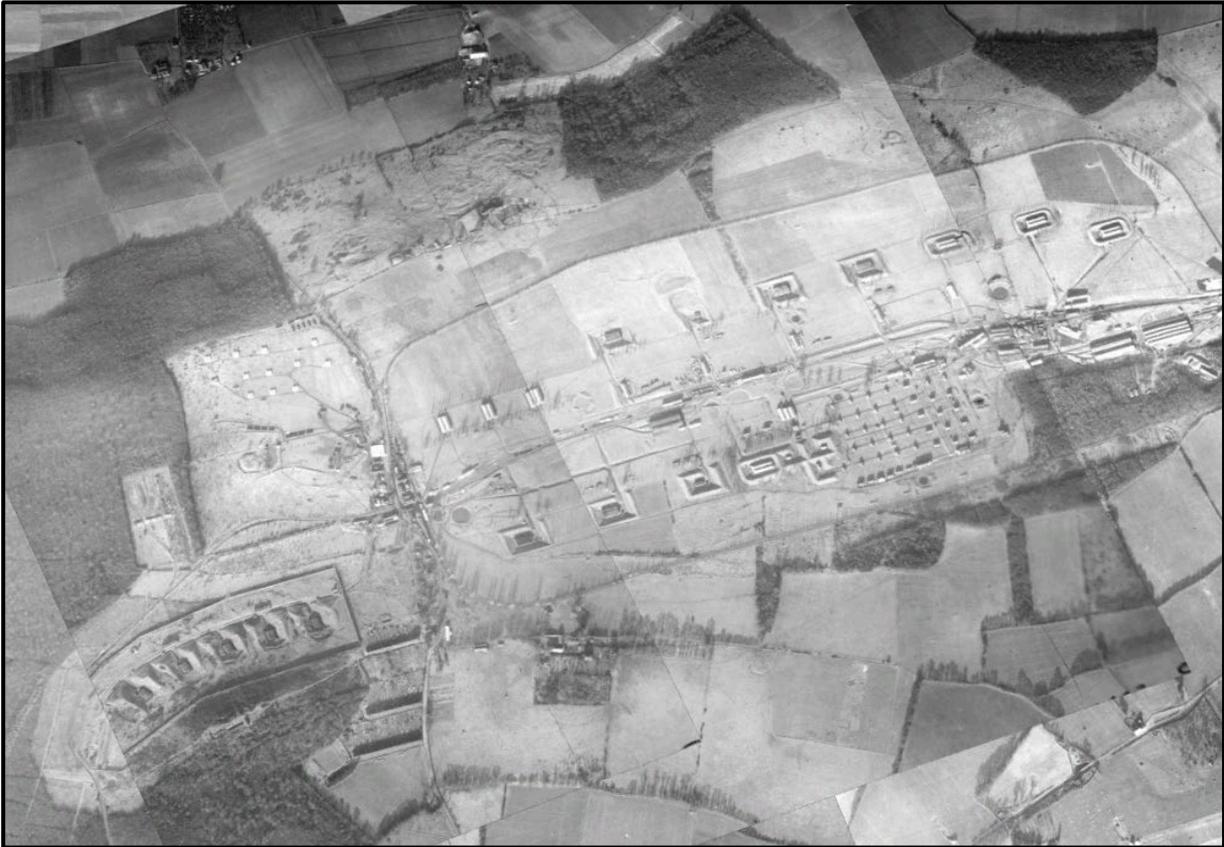
Figure 5. Showing XXXXXXXXX and Ordnance storage in 1940. Individual storage facilities are visible as well as AA emplacements and barracks buildings to the west.

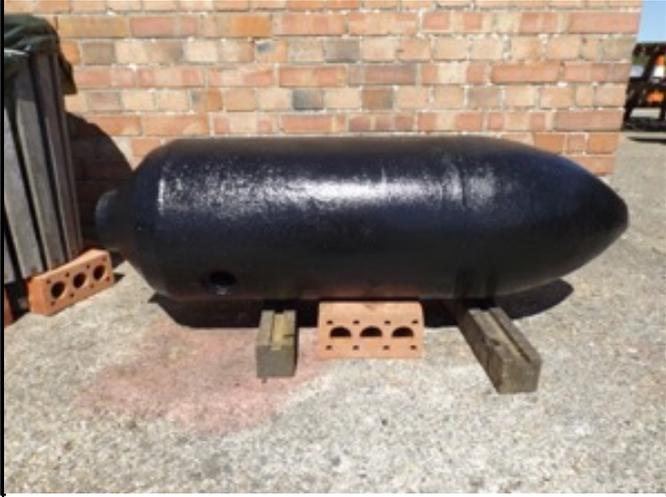
<p>The SC series of HE Bombs were a thin cased general-purpose bomb used as general demolition bombs.</p>
	<p>German SC250 (recovered casing)</p>	<p>Most bombs were 50kg, 250kg or 500kg, although larger bombs of up to 1,800kg were also used. About half the weight of these HE bombs comprised of explosive fill.</p>

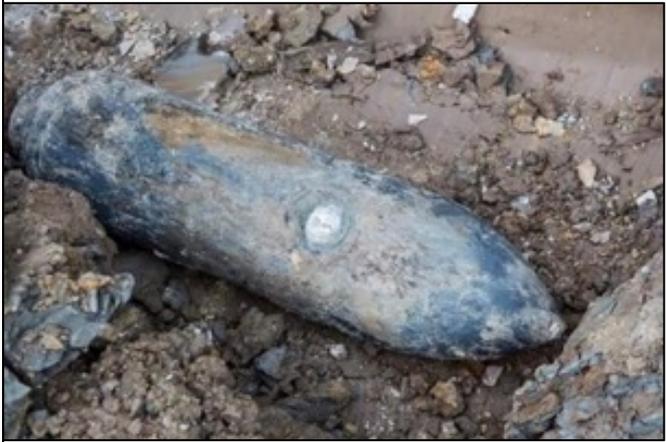
<p>The SC50 had a one-piece drawn steel body and its total weight was 48 to 55 kg.[1] It was dropped on targets across the UK.</p>
<p>German SC50 (London 2015)</p>	<p>The SD series of bombs were thicker cased, with a lower charge weight used against hardened targets.</p>

*When bombs strike but do not detonate, they can easily remain undetected. Note that the entry hole of an SC50 (the most commonly deployed German HE bomb) could have been as small as 20cm in diameter and therefore easily obscured within dense crops, or unmaintained vegetation, rough soil or rubble from previous damage.*

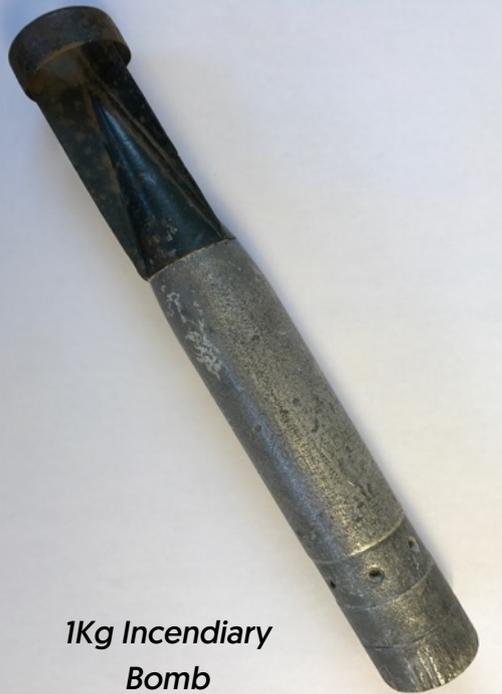
<div style="margin-left: 10px;"> <p><i>The 1 kg B1E incendiary bomb consisted of a cylinder of magnesium alloy, with an incendiary filling of thermite. Rivetted to the body was a steel tail with three fins. These bombs did not explode but were ignited by a small percussion charge, fired upon impact. They were dropped in a variety of containers. Later an explosive head was incorporated into the IB.</i></p> </div> </div> <p style="text-align: center;"><i>1Kg Incendiary Bomb</i></p>

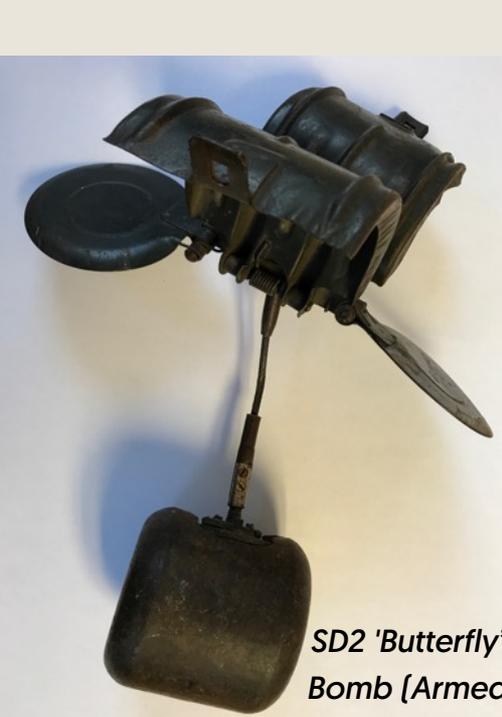
<div style="margin-left: 10px;"> <p><i>A Butterfly Bomb (or Sprengbombe Dickwandig 2 kg or SD2) was a German 2 kilogram anti-personnel submunition used by the Luftwaffe during the Second World War. It was so named because the thin cylindrical metal outer shell which hinged open when the bomblet deployed gave it the superficial appearance of a large butterfly. The design was very distinctive and easy to recognise. SD2 bomblets were not dropped individually but were packed into containers holding between 6 and 108 submunitions. These broke open in air and scattered the submunitions.</i></p> </div> </div> <p style="text-align: center;"><i>SD2 'Butterfly' Bomb (Armed status)</i></p>

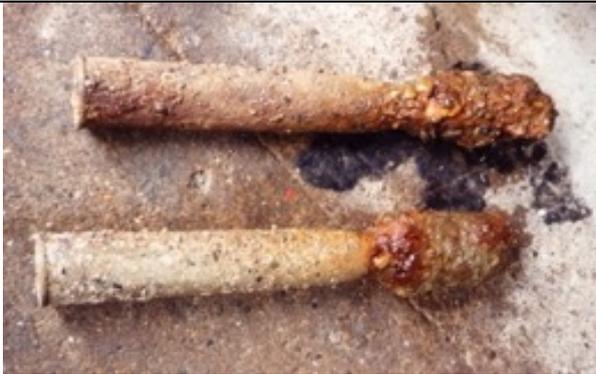
<p>40mm AA Shells found at W Sussex site</p>	<p>Fixed (Heavy) Anti-Aircraft batteries were set up all around the country to defend potential targets from aerial attack. Size of guns and shells ranged from small, quick-firing 40mm Bofors guns to larger 3.7 or 4.5inch guns.</p> <p>3.7 Inch = 12.7kg 94mm x 438mm            40mm = 0.9kg 40mm x 311mm            4.5 Inch = 24.7kg 114mm x 578mm</p>

LAA batteries were intended to engage fast, low flying aircraft and were typically deployed around military bases, RAF airfields or important installations. These batteries were mobile and could be moved to new positions with relative ease when required. The most numerous of these were the 40mm Bofors gun, which could fire up to 120 x 40mm HE shells per minute to over 1,800m.

HAA projectiles were high explosive shells, usually fitted with a time delay or a barometric pressure fuze to make them explode at a pre-determined height. If they failed to explode or strike an aircraft, they would eventually descend back to earth.

Although the larger unexploded fall-to-earth projectiles could enter beneath the ground surface, they did not have a great penetration ability and are therefore likely to be found close to WWII ground level. If encountered, the high explosive fill and fragmentation hazard of these items of UXO would present a significant risk.

*The smaller 40mm projectiles are similar in appearance and effect to SAA and, although still dangerous, present a lower hazard due to its decreased explosive content.*

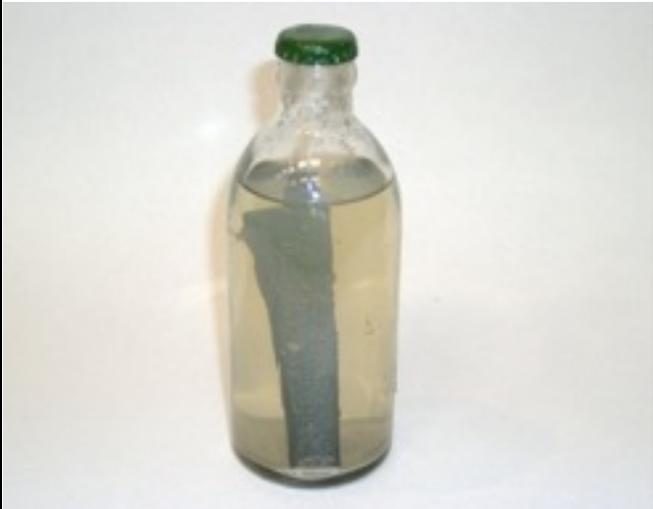
Type	Description	
No.76 SIP Grenade

<p>No.76 SIP (Self Igniting Phosphorus) grenades. These items, resembling a milk bottle are frequently found during shallow excavations or building demolition and although small in size can inflict life-changing injuries if not dealt with correctly.</p> <p>Found in wooden crates of 24 items.</p>

*Items may include small arms ammunition, mortar bombs and hand grenades or even crudely manufactured defensive weapons designed for Home Guard use such as the No.76 SIP (Self Igniting Phosphorus) grenades. These items, resembling a milk bottle are frequently found in original crates during shallow excavations or building demolition and although small in size can inflict life-changing injuries if not dealt with correctly.*

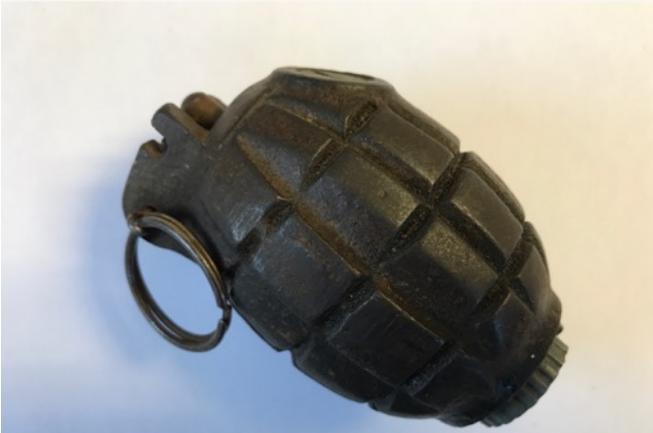
Type	Description	
Hand Grenades

<p>British No36 'Mills' arenade</p>	<p>Contains a small amount of High Explosive and a rudimentary time delay fuze.</p> <p>The absence of a pin and fly-off handle indicate the item is potentially live.</p> <p>The distinctive segmented (Pineapple) casing gives the</p>

<i>fragmentation effect on detonation.</i>
--	--	--

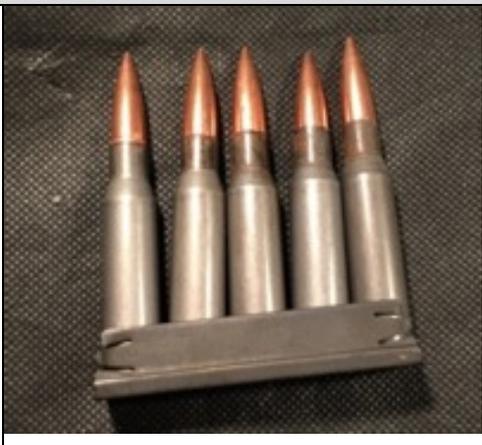
<p>Small arms of various sizes from 4 or 5mm calibre (diameter) up to 12 to 13mm.</p> <p>Generally, the head is inert and made of lead or similar dense material.</p> <p>Brass cases without the head pose no risk.</p>

The most common type of ordnance encountered on land formerly used by the military are items of Small Arms Ammunition (SAA). SAA refers to the complete round or cartridge designed to be used with hand-held infantry weapons such as rifles, machine guns and pistols. SAA can include bullets, cartridge cases and primers/caps. Items of SAA can be accidentally initiated by striking the casing or coming into contact with fire. SAA presents only minimal risk although it must be disposed of correctly if found on-site.
